CASE HISTORY HONDA CRV ABS.

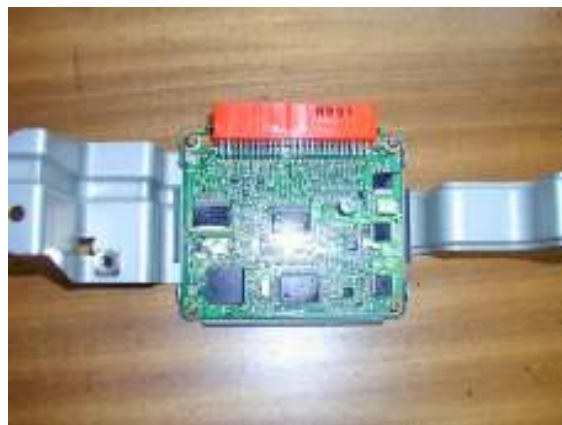
WE WERE ASKED TO INVESTIGATE THE ABS SYSTEM ON A 2001 HONDA CRV; THE WARNING LIGHT WAS ON ALL THE TIME. FAULT CODE INFORMATION REVEALED A CODE FOR MAIN RELAY FAILURE. FURTHER TESTING CONFIRMED THIS TO BE THE CASE. WE ATTEMPTED TO ORDER A NEW RELAY VIA OUR LOCAL MAIN DEALER THEY SUPPLIED A COMPLETE MODULATOR WHICH UPON INVESTIGATION WAS INCORRECT THE MAIN RELAY WAS INSIDE THE ELECTRONIC CONTROL UNIT (SEE BELOW)

THIS IS A TYPICAL HYBRID CIRCUIT THAT IS NOW USED IN MOST MODERN CARS AND IS NOT REPAIRABLE. THE COST OF THIS UNIT £1200 INC VAT
