## CASE HISTORY MERCEDES ML

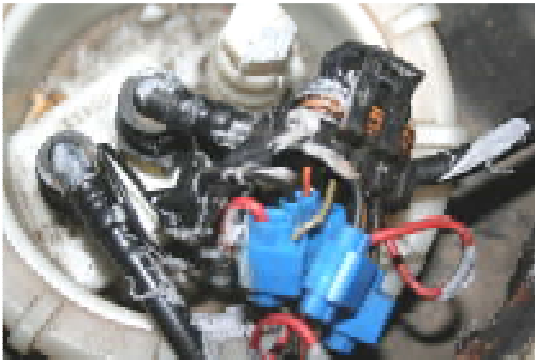
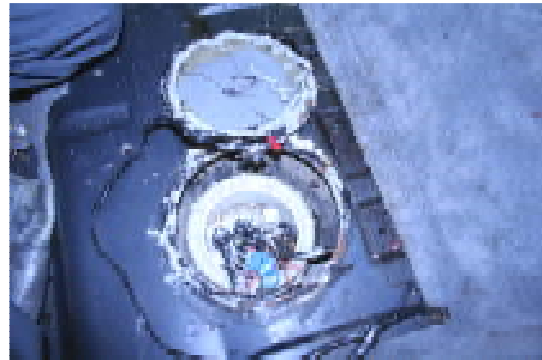
**VEHICLE FAULTS:-** Intermittent cutting out and non start and SRS light on .

**VEHICLE HISTORY: -** The vehicle had recently been repaired for the same fault .The repair had consisted of wiring repair to the fuel pump.

**TESTING:-** Testing procedures with our Autologic test equipment revealed that when the vehicle cut out the fuel pressure was lost test to drive the fuel pump proved unsuccessful .After stripping out the rear seats we found one of the worst repairs we have ever seen on wiring see picture below . Both the SRS wiring was damaged and the wiring to the fuel pump had been very poorly repaired. Repairing the SRS wiring, replacing the fuel pump with a new Wiring harness cured the fault.
