CASE HISTORY HONDA CRV ABS.

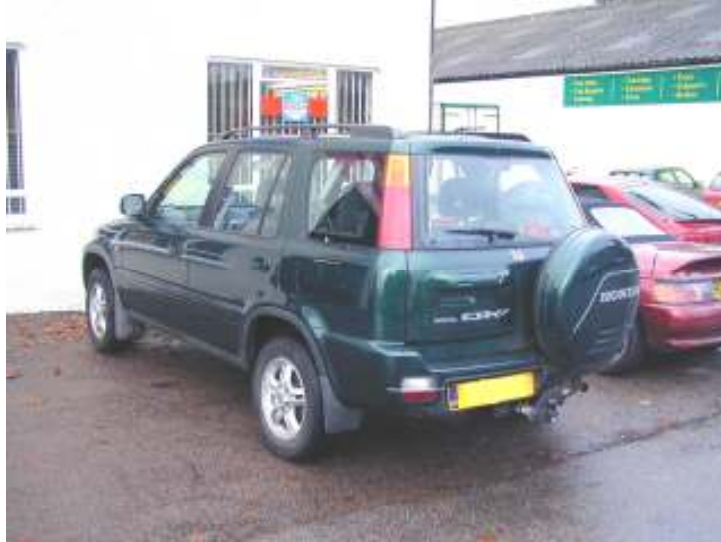
WE WERE ASKED TO INVESTIGATE THE ABS SYSTEM ON A 2001 HONDA CRV; THE WARNING LIGHT WAS ON ALL THE TIME. FAULT CODE INFORMATION REVEALED A CODE FOR MAIN RELAY FAILURE. FURTHER TESTING CONFIRMED THIS TO BE THE CASE. WE ATTEMPTED TO ORDER A NEW RELAY VIA OUR LOCAL MAIN DEALER THEY SUPPLIED A COMPLETE MODULATOR WHICH UPON INVESTIGATION WAS INCORRECT THE MAIN RELAY WAS INSIDE THE ELECTRONIC CONTROL UNIT (SEE BELOW)
